# A Case Study on Kommativani Cheruvu, Madanapalle, Annamaya District

**Abstract** - Kommativani Cheruvu, located in Madanapalle, is an important traditional water body that supports irrigation, groundwater recharge, and ecological balance. In recent years, the cheruvu has been subjected to environmental stress due to rapid urbanization, agricultural runoff, and discharge of untreated domestic wastewater. This study aims to assess both the water and soil quality of Kommativani Cheruvu through comprehensive physicochemical and environmental analysis. Water samples were collected from multiple locations and analysed for parameters such as pH, Turbidity, Dissolved Oxygen (DO), Biochemical Oxygen Demand (BOD), and Chemical Oxygen Demand (COD). Simultaneously, soil samples from the cheruvu bed and surrounding areas were examined for properties including pH, moisture content, organic matter, and possible contamination by heavy metals. All analyses were carried out following standard procedures recommended by CSIR-NEERI. The results indicate deterioration in water quality, with elevated BOD and COD levels and reduced dissolved oxygen, suggesting significant organic pollution and the onse

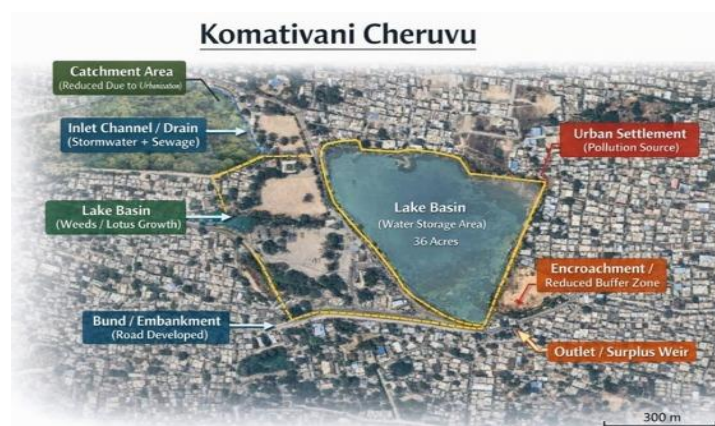
Figure 3: Layout of kommativani cheruvu

The catchment area is the region that collects rainfall and directs it into the lake. The catchment has been increasing due to rapid urbanization, decreasing the amount of clean rainwater entering the lake. The inlet channel carries both storm water and untreated domestic sewage into the lake. This mixed inflow is the primary source of pollution, increasing organic matter, nutrients, and contaminants in the lake water. Lake Basin is the central portion of stores water. The presence of weeds and lotus growth indicates nutrient enrichment (eutrophication), caused mainly by continuous sewage discharge. Urban Settlement Residential colonies surrounding the lake act as the major pollution source. Domestic wastewater, solid waste, and runoff from these settlements contribute significantly to water quality deterioration. Encroachment and Reduced Buffer Zone as encroachments around the lake boundary, resulting in a reduced buffer zone. This limits natural filtration of pollutants, reduces biodiversity, and increases the risk of direct contamination. Bund (Embankment) bund has been developed as a road, which protects the lake boundary and allows access. However, proper maintenance is essential to prevent erosion and ensure the structural stability of the lake.

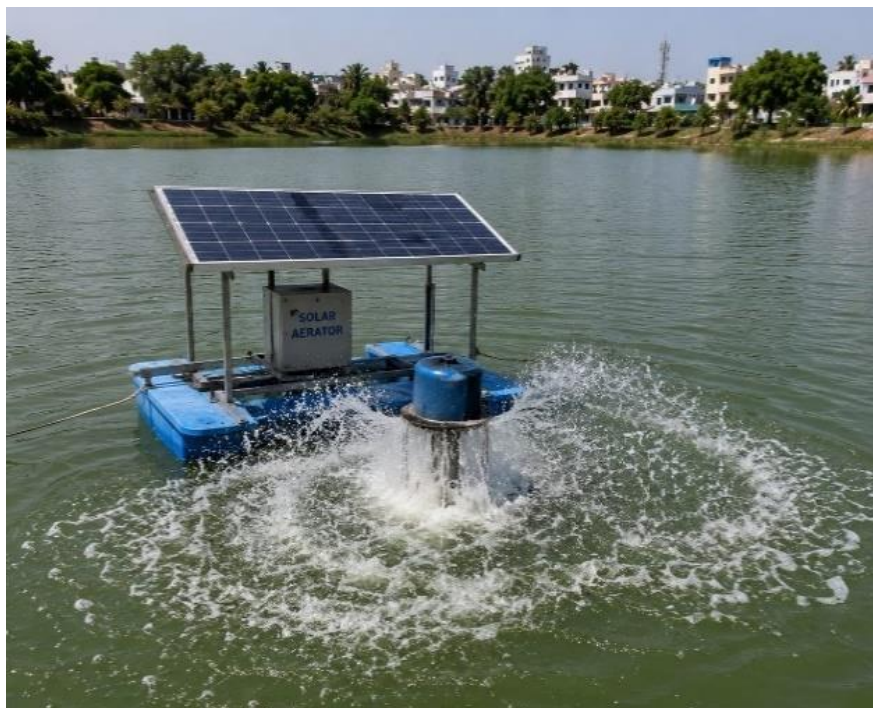
Solar aeration is an eco-friendly technology used to improve water quality in lakes by increasing the dissolved oxygen (DO) levels using solar energy. In water bodies like Kommativani Cheruvu in Madanapalle, where sewage inflow reduces oxygen levels, solar aeration plays a crucial role in restoring ecological balance. The system consists of solar panels, a compressor or pump, and diffusers placed in the lake. Solar panels generate electricity, which powers the aeration system to pump air into the water through diffusers.

**Figure 5: Solar Aerator for cleaning of lake**

These diffusers release fine air bubbles that increase oxygen transfer into the water. As a result, dissolved oxygen levels rise, helping aquatic organisms survive and promoting the breakdown of organic pollutants. Solar aeration is particularly effective in reducing Biochemical Oxygen Demand (BOD) and controlling foul odors caused by anaerobic conditions. It also helps in minimizing algal blooms and improving overall water clarity. Since the system operates on renewable solar energy, it is cost-effective, requires low maintenance, and is suitable for semi-urban areas. For effective implementation, aerators should be installed near inlet zones where sewage enters the lake, as well as in deeper sections to ensure uniform oxygen distribution. This technology can be combined with other methods such as phytoremediation and sewage diversion for better results.

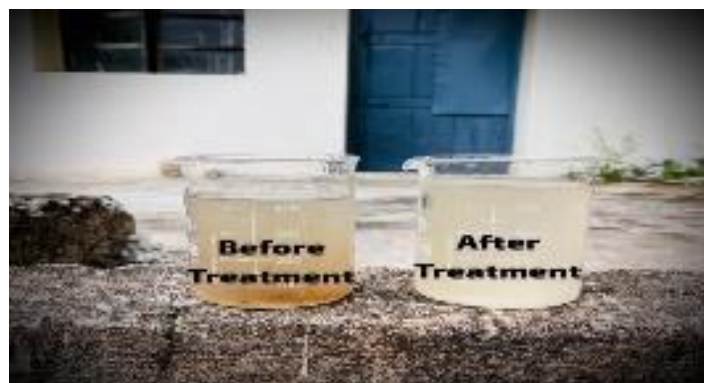
Figure 12: Shows before and after treatment

Sustainable remediation technology recommended for improving water quality in polluted water bodies. As per the strategies follow by Andhra Pradesh Pollution Control Board (APPCB), floating wetlands are used as an in-situ treatment method for lakes receiving domestic sewage and urban runoff. In this system, artificial floating platforms are installed on the water surface, supporting the growth of selected aquatic plants such as Elephant grass, Common Reed, Bulrush Alligator weed, Paspalum Vaginatum, Heliconia plant. The plant roots extend into the water column and act as a bio-filtration medium, absorbing excess nutrients like nitrogen and phosphorus, which are the primary causes of eutrophication. The root zone provides a surface for microbial growth, forming a biofilm that facilitates the degradation of organic pollutants, thereby reducing Biochemical Oxygen Demand (BOD) and Chemical Oxygen Demand (COD) levels. This process enhances the overall water quality and supports aquatic life.
