Failure Investigation of the Front Coil Spring of a 160 cc Motorcycle

Abstract - Coil springs in motorcycles are crucial components in the vehicle's suspension system, where they are used in the front or rear to absorb the impact energy experienced by the wheels. In this study, the coil spring experienced a failure in the form of fracture, prompting several tests to analyze the mechanism and causes of this failure. The conducted tests include visual observation, chemical composition testing, metallographic testing, hardness testing, and FEM simulation. The visual observation results indicate that the failure experienced by the coil spring is due to fatigue fracture, as defined by the presence of crack initiation, crack propagation (beachmark), and final rupture. The chemical composition testing reveals that the material used is SAE 9254 Steel, that is a low-alloy steel. The microstructure formed consisted of ferrite and pearlite phases, attributed to the absence of quenching and tempering processes during the coil spring's production. The hardness testing results show an average hardness of 216,6 HV, confirming the absence of quenching and tempering in the coil spring production p

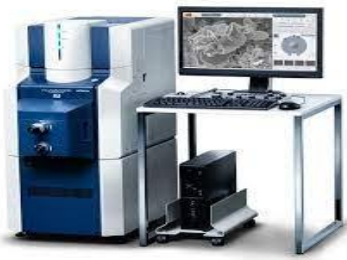
Figure 1: Hitachi flexem 1000

Several testing procedures need to be conducted to determine the type and causes of the fractures in this research, including chemical composition analysis, visual observations, metallography testing, Vickers hardness testing, and finite element numerical simulations. The chemical composition analysis uses the Hitachi Flexem 1000 as depicted in Figure 1. The purpose of this testing is to determine the type of material utilized and the chemical makeup of the coil spring.

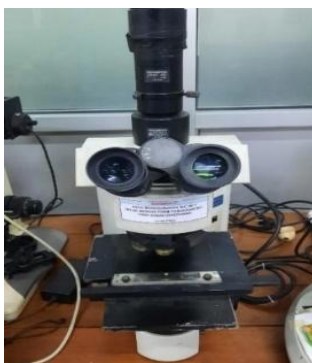
Figure 3: Optical microscope

Metallography testing uses several processes, namely cutting the specimen, making mountings on the specimen, sanding, polishing, etching, and finally observing the material grains using an optical microscope, as seen in Figure 3 below.

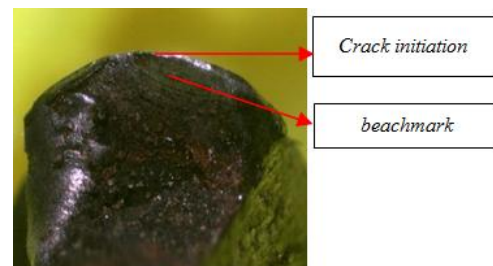
Based on visual observations conducted on the coil spring, it can be determined that the coil spring has experienced a fatigue failure. Figures 5, 6, and 7 illustrate the fractures on the coil spring.

Figure 5: Crack initiation, crack propagation (beachmark)

2. The failure mechanism for a failed coil spring occurs due to fatigue fracture. Where fatigue fracture is characterized by crack initiation, crack propagation and final rupture.

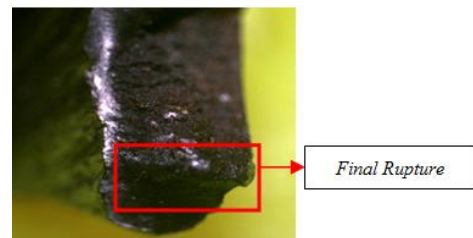
Figure 6: Final rupture

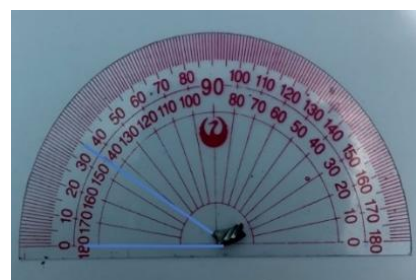
Figure 7: Fracture angle

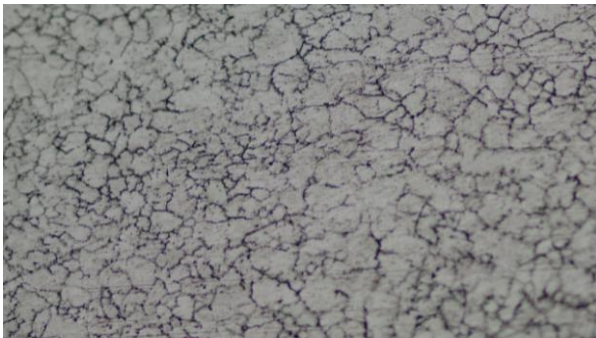
Figure 8: Results of metallographic testing near the failure coil spring 500X magnification scale

From Figure 8 and Figure 9 above, it can be seen that the phase shape of the coil spring part of the failed specimen and the non-failed part have the same phase, namely pearlite ferrite, which is caused by the absence of quenching and tempering processes in the manufacturing process.

1. The test results show that the chemical composition of the coil spring components is made of low alloy steel with a chromium alloy value of 0,68%. The microstructure formed is the pearlite ferrite phase. The phase formed is caused by the coil spring, most likely not

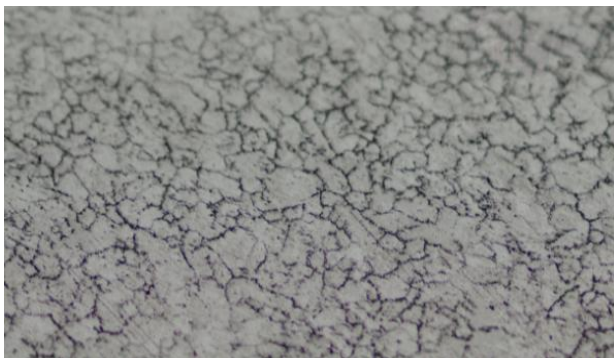
Figure 9: Results of metallographic testing far the failure coil spring 500X magnification scale.

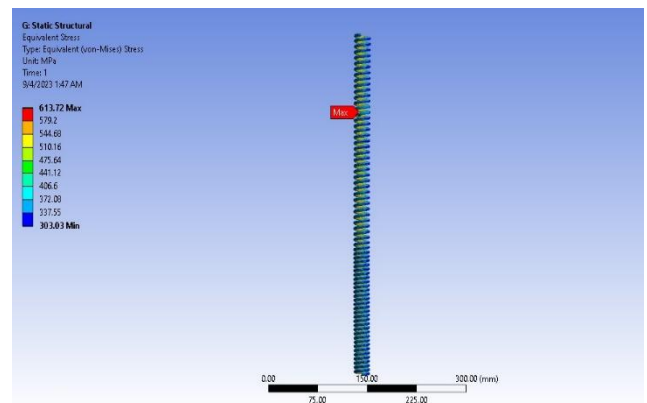
Figure 10: Von-mises stress

Simulations were carried out to analyze the stress in the coil spring. The applied force has been calculated and the force on the coil spring is 463,05 N and the torsional moment is 5.731,38 N.mm. The simulation results can be seen in Figure 10.
